**Flood Control Project Maintenance
Levee Inspections**

Fall 2016 Levee Maintenance Deficiency Summary Report

San Joaquin River Basin

Reclamation District No. 2063 Crows Landing

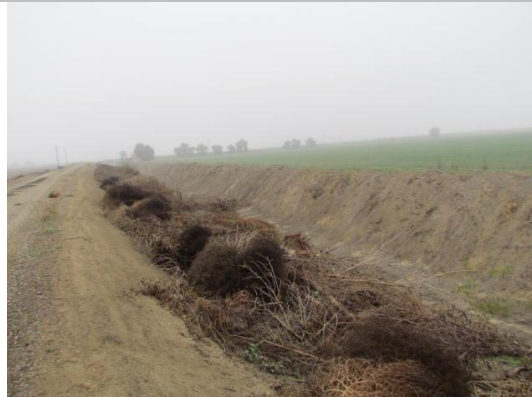
Photo 1 of 3 : FA_2016_RD2063_112_18_20161007_00004.jpg

Looking north at ditch on landside berm and toe.

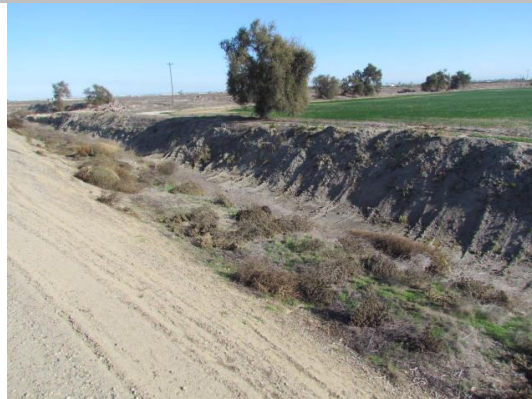
Photo 2 of 3 : FA_2016_RD2063_112_18_20161007_00005.jpg

Looking northeast at canal-ditch on landside berm.

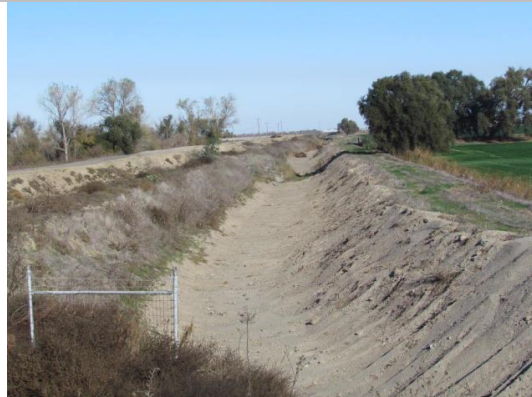
Photo 3 of 3 : FA_2016_RD2063_112_18_20161007_00006.jpg

Looking south at canal-ditch at landside berm and toe.

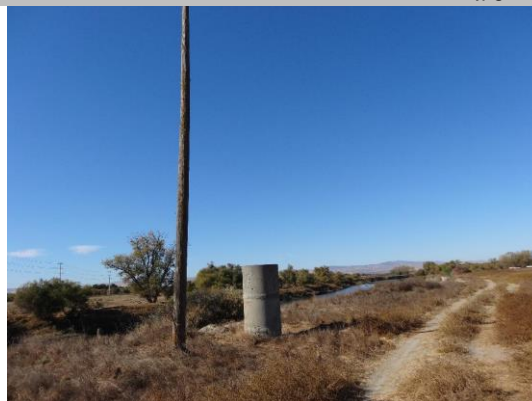
Photo 1 of 2 : UCIP_FA_2016_50216_43166.jpg

11/05/2013:- Pipe has visible holes throughout both LS and WS along with pipe deformation. - looks abandoned. Needs proper abandonment.- alfalfa valve on concrete pipe riser on waterside toe.- no slide gate found on waterside. No pump and pile structure found in river.

FIELD_STRUCT_DESC: *ABANDONED* 24-inch corrugated metal (CMP) pipe through the levee, 10 feet below the crown, not found during 2016 inspection. Pipe was supported on two timber pile bents across a drain ditch on the landside (LS) (only pile remnants found during 2016 inspection). Two concrete standpipes on waterside (WS) berm, one of which was found during the 2016 inspection. [Additional Reference(s): DWR Levee Log, 1992. USACE San Joaquin O&M Manual 006, Sep 1961 (HLM 1.29)].

WS view: abandoned concrete standpipe and abandoned power pole.

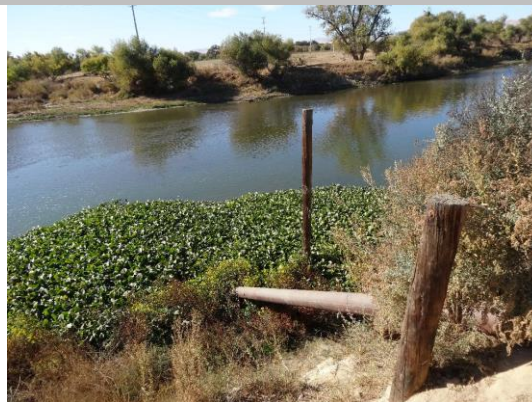
Photo 2 of 2 : UCIP_FA_2016_50216_43161.jpg

WS view: steel pipe immersed into the river. No pump found.

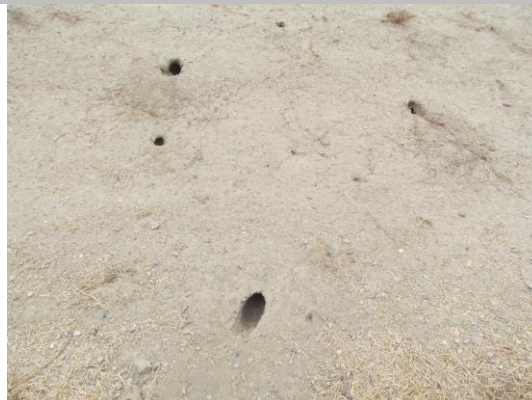
Photo 1 of 2 : FA_2016_RD2063_112_11_20161027_00085.jpg

LM Start	1.71	Rating **	U	Issue No.	11
LM End	1.74	Issue Type +	Ma	Location *	LS
Category	Earthen Levee			GPS Latitude/Longitude	
				Start	End
Item	Animal Control			37.459209 °	37.458964 °
				-121.033126 °	-121.033420 °
DWR ID	DWR_RD2063_01_s _ 2012_11				
Comment Code					
A3 : No rodents visible, but rodent burrows visible; need to backfill and compact or grout burrows.					
Inspector Comment					
Several rodent holes noted on landward slope.

Looking at several rodent holes on landward slope.

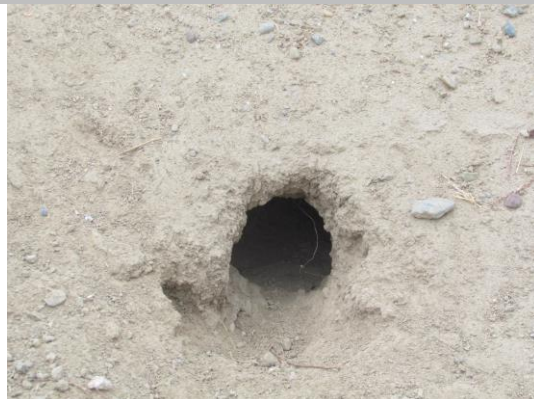
Photo 2 of 2 : FA_2016_RD2063_112_11_20161027_00083.jpg

LM Start	1.71	Rating **	U	Issue No.	11 (cont)	
LM End	1.74	Issue Type +	Ma	Location *	LS	
Category	Earthen Levee			GPS Latitude/Longitude		
				Start		End
Item	Animal Control			37.459209 °		37.458964 °
				-121.033126 °		-121.033420 °
DWR ID	DWR_RD2063_01_s_2012_11					
Comment Code						
A3 : No rodents visible, but rodent burrows visible; need to backfill and compact or grout burrows.						
Inspector Comment						
Several rodent holes noted on landward slope.

Looking at close-up view of rodent hole on landward slope.

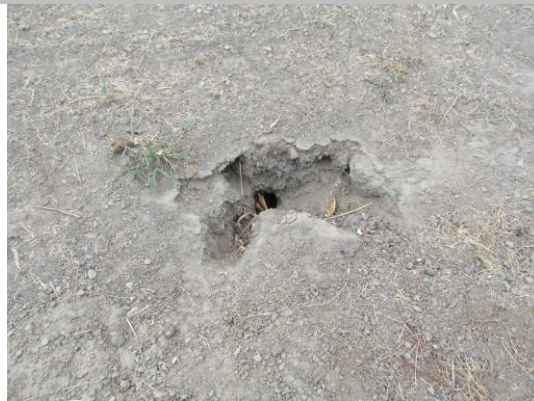
Photo 1 of 2 : FA_2016_RD2063_112_46_20161027_00086.jpg

LM Start	2.01	Rating **	U	Issue No.	46
LM End	2.01	Issue Type +	Ma	Location *	LS
Category	Earthen Levee			GPS Latitude/Longitude	
				Start	End
Item	Animal Control			37.455136 °	37.455136 °
				-121.032912 °	-121.032912 °
DWR ID	DWR_RD2063_01_f_2016_46				
Comment Code					
A3 : No rodents visible, but rodent burrows visible; need to backfill and compact or grout burrows.					
Inspector Comment					
Three large rodent holes on landward slope.

Looking at large rodent hole on landward slope.

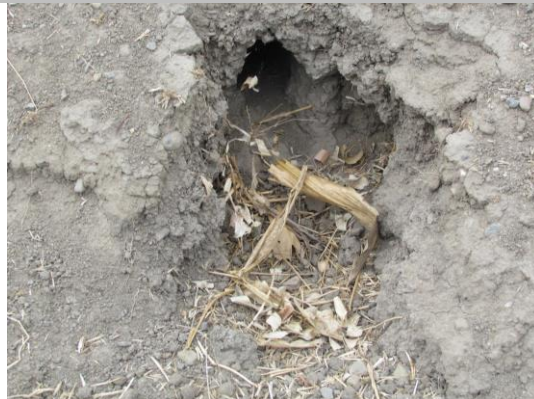
Photo 2 of 2 : FA_2016_RD2063_112_46_20161027_00087.jpg

Looking at close-up view of rodent hole with corn husk at the entrance of the hole.

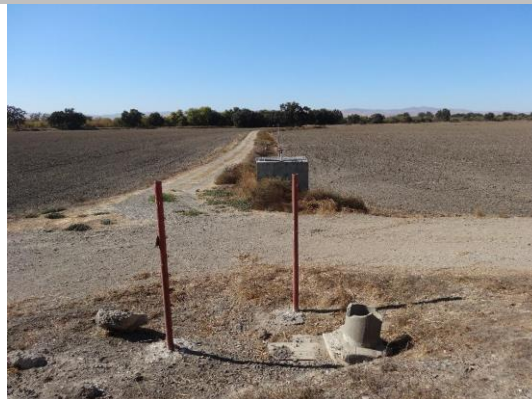
Photo 1 of 2 : UCIP_FA_2016_24404_43345.jpg

LM Start	2.09	Rating **	M	Issue No.	989
LM End	2.09	Issue Type +	En	Location *	LS
Category	Supplemental			GPS Latitude/Longitude	
				Start	End
Item	DWR UCIP Field Study			37.454125 °	37.454125 °
				-121.032240 °	-121.032240 °
DWR ID					
Comment Code					
Inspector Comment					
FS_ID:24404					
DS_ID:22078					
EP_NO: N/A					
Repair Type: Non-Urgent					
Crossing Status: Found					
UCIP Comments: Concrete distribution box with alfalfa valve not found at the waterward toe.Two steel standpipes and dismantled concrete standpipe on waterside levee toe.Concrete distribution box 50 ft off the levee center.					
FIELD_STRUCT_DESC: 30-inch CM pipe through the levee 16.5 feet below the crown. Slide gate in concrete distribution box 50 ft off the levee. Underground irrigation system. Installed by USCE 1961. O&M Manual SJR 006, Sept. 1961.					
FS Date: 11/5/2013

WS view: concrete box (top), and a dismantled concrete pipe on levee toe.

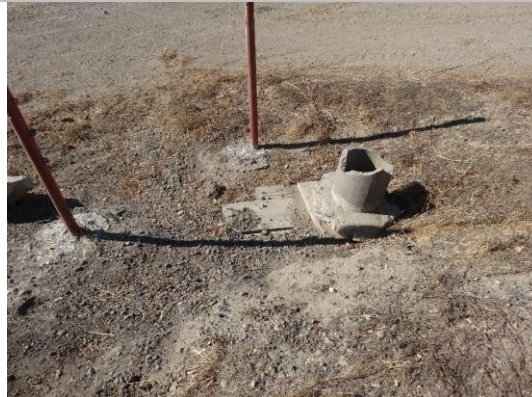
Photo 2 of 2 : UCIP_FA_2016_24404_43344.jpg

WS view: a dismantled concrete pipe on levee toe.

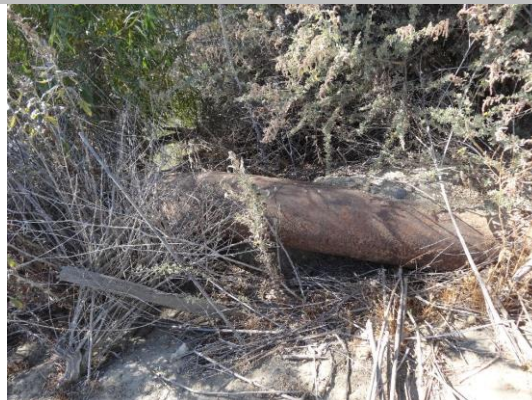
Photo 1 of 2 : UCIP_FA_2016_24427_43439.jpg

Comment Code					
Inspector Comment					
FS_ID:24427					
DS_ID:22085					
EP_NO: N/A					
Repair Type: Non-Urgent					
Crossing Status: Found					
UCIP Comments: Abandoned steel pipe and service pole on waterside.					
Pump not found on river bank. CMP riser on waterside slope. Slide					
gate not found in CMP riser. Steel pipe riser on waterside					
berm.Damaged PVC standpipe on waterside slope.					
FIELD_STRUCT_DESC: Abandoned 24-inch CM pipe through the					
levee 10.0 feet below the crown. 20-inch standpipe 3.0 feet from the					
landward toe. 12-inch pipe across the berm and into CMP riser on the					
waterward slope. Installed by USCE 1961. O&M Manual SJR 006, Sept.					
1961.					
FS Date: 11/5/2013

WS view: abandoned steel pipe on river bank. No pump found on river bank.

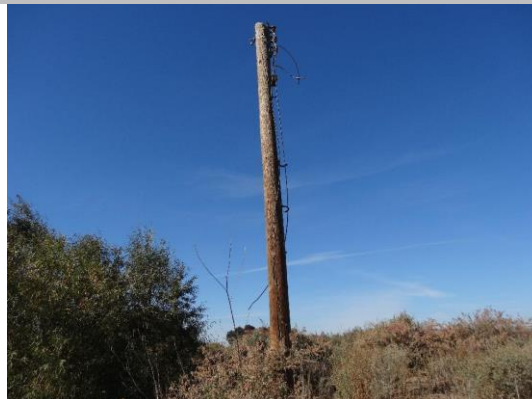
Photo 2 of 2 : UCIP_FA_2016_24427_43438.jpg

WS view: abandoned power pole on levee berm.

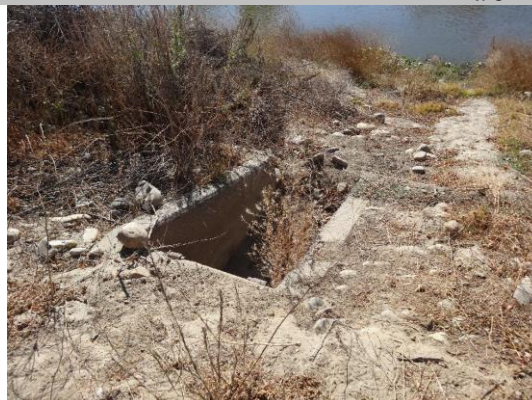
Photo 1 of 2 : UCIP_FA_2016_24435_43484.jpg

LM Start	2.62	Rating **	M	Issue No.	991	
LM End	2.62	Issue Type +	En	Location *	LS	
Category	Supplemental			GPS Latitude/Longitude		
				Start	End	
Item	DWR UCIP Field Study			37.448233 °	37.448233 °	
				-121.026521 °	-121.026521 °	
DWR ID						
Comment Code						
Inspector Comment						
FS_ID:24435						
DS_ID:22086						
EP_NO: N/A						
Repair Type: Non-Urgent						
Crossing Status: Found						
UCIP Comments: Both pipe ends 70 ft off the levee center.Cleaning and cleaning of inlet/outlet pipe needed.						
FIELD_STRUCT_DESC: 24-inch CM pipe through the levee 12.0 feet below the crown. Flap gate on the waterward end. Concrete headwall on both ends. Installed by USCE 1961. O&M Manual SJR 006, Sept. 1961.						
FS Date: 11/5/2013

WS view: U shaped headwall outlet structure 70 ft off the levee center.

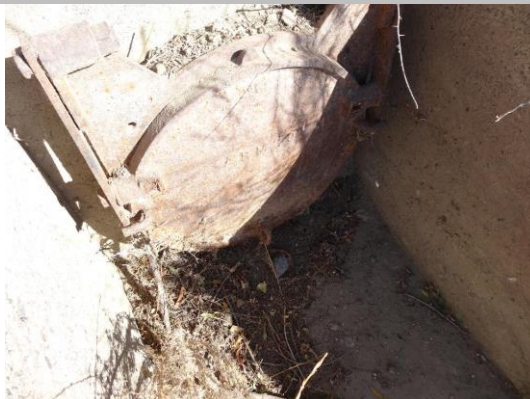
Photo 2 of 2 : UCIP_FA_2016_24435_43483.jpg

WS view: U shaped headwall outlet structure and pipe with flap gate.

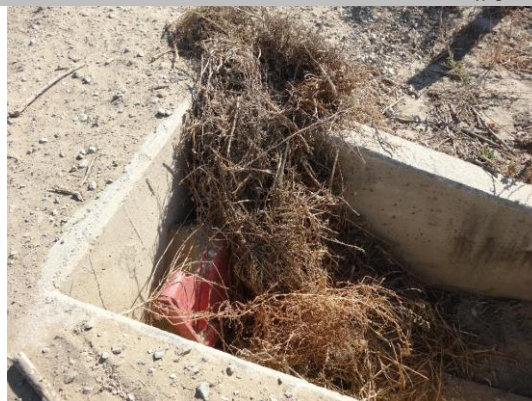
Photo 1 of 2 : UCIP_FA_2016_24443_43522.jpg

FS_ID:24443
DS_ID:22088
EP_NO: N/A
Repair Type: Non-Urgent
Crossing Status: Found
UCIP Comments: - clear and clean debris
FIELD_STRUCT_DESC: Abandoned 24-inch CM pipe through the levee 9.5 feet below the crown. Flap gate on the waterward end. Pipe open on landward end. Concrete headwall on both ends. O&M Manual SJR 006, Sept. 1961
FS Date: 11/5/2013

WS view: U typed concrete headwall on levee slope.

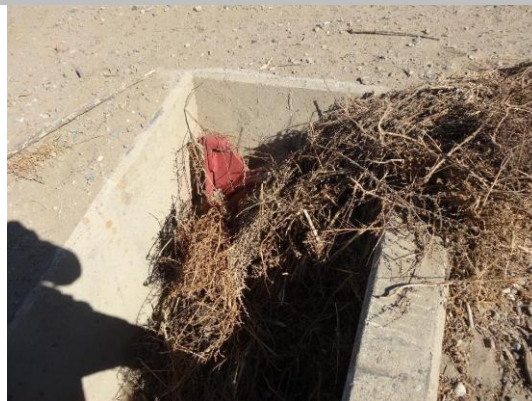
Photo 2 of 2 : UCIP_FA_2016_24443_43521.jpg

WS view: pipe, flap gate, and concrete headwall with debris blocking the outlet.

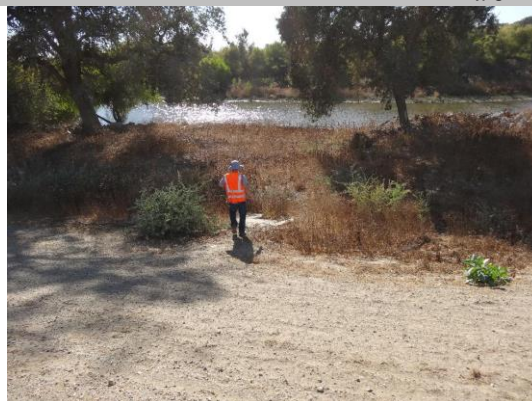
Photo 1 of 2 : UCIP_FA_2016_24469_43645.jpg

LM Start	3.29	Rating **	M	Issue No.	993
LM End	3.29	Issue Type +	En	Location *	LS
Category	Supplemental			GPS Latitude/Longitude	
				Start	End
Item	DWR UCIP Field Study			37.441213 °	37.441213 °
				-121.021130 °	-121.021130 °
DWR ID					
Comment Code					
Inspector Comment					
FS_ID:24469					
DS_ID:22089					
EP_NO: N/A					
Repair Type: Non-Urgent					
Crossing Status: Found					
UCIP Comments: - cleaning required in inlet pipe.- new flap gate					
FIELD_STRUCT_DESC: 24-inch CM pipe through the levee 12.5 feet					
below the crown. Flap gate on the waterward end. Concrete headwall					
on both ends. O&M Manual SJR 006, Sept. 1961.					
FS Date: 11/5/2013

WS view: U typed concrete headwall on levee toe

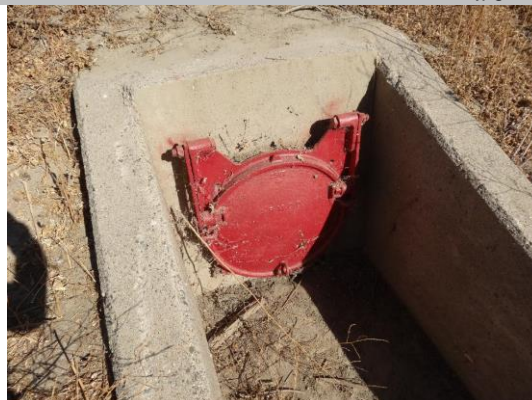
Photo 2 of 2 : UCIP_FA_2016_24469_43644.jpg

WS view: new flap gate, and U typed concrete headwall.

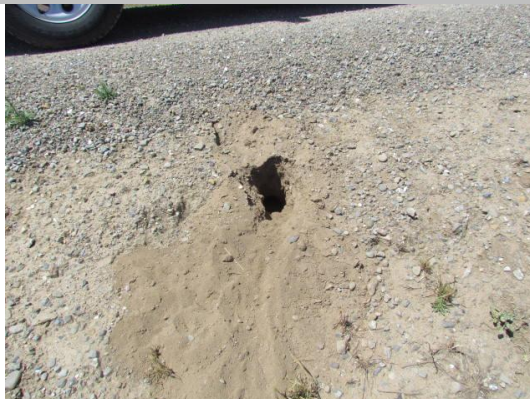
Photo 1 of 2 : FA_2016_RD2063_112_53_20161007_00018.jpg

Looking east at typical rodent hole on landward shoulder.

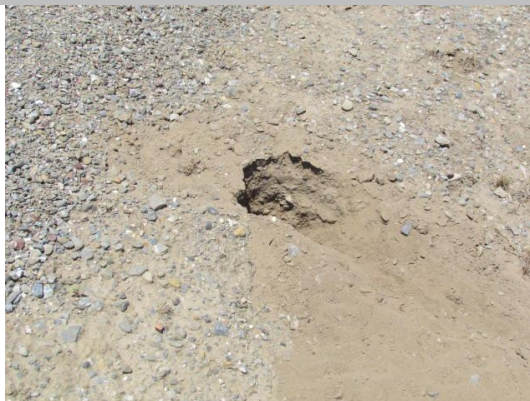
Photo 2 of 2 : FA_2016_RD2063_112_53_20161007_00019.jpg

Looking southeast at typical rodent hole on landward slope.

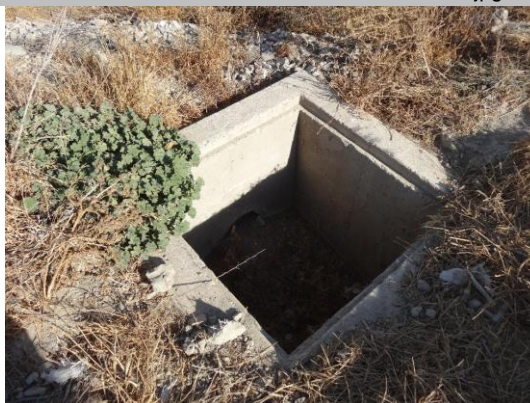
Photo 2 of 2 : UCIP_FA_2016_24485_43666.jpg

LS view: concrete drop inlet box on levee toe.

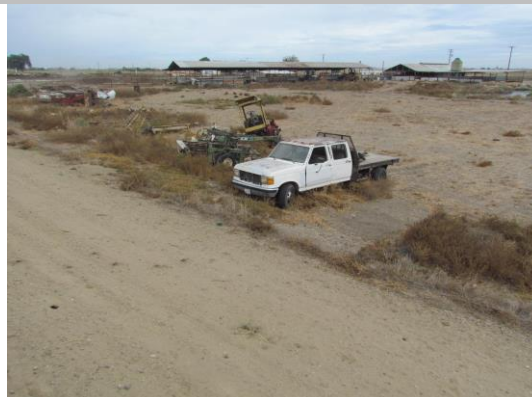
Photo 1 of 1 : FA_2016_RD2063_112_49_20161027_00091.jpg

Looking east at truck and other farm equipment at landward toe.

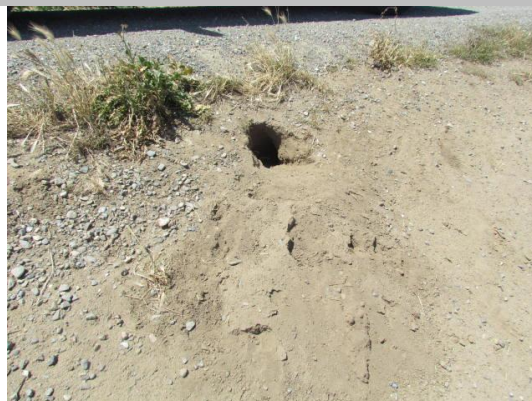
Photo 1 of 2 : FA_2016_RD2063_112_29_20161007_00007.jpg

LM Start	3.68	Rating **	M	Issue No.	29
LM End	3.76	Issue Type +	Ma	Location *	LS
Category	Earthen Levee			GPS Latitude/Longitude	
				Start	End
Item	Animal Control			37.436421 °	37.435767 °
				-121.017321 °	-121.016119 °
DWR ID	DWR_RD2063_01_s_2012_29				
Comment Code					
A3 : No rodents visible, but rodent burrows visible; need to backfill and compact or grout burrows.					
Inspector Comment					
Several rodent holes on landward shoulder and slope.

Looking east at typical rodent hole on landward shoulder.

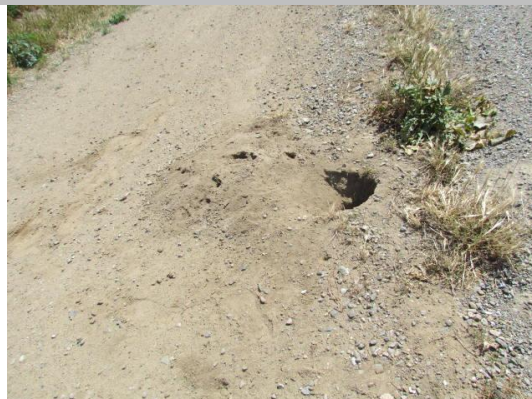
Photo 2 of 2 : FA_2016_RD2063_112_29_20161007_00008.jpg

Looking south at typical rodent hole on landward shoulder.

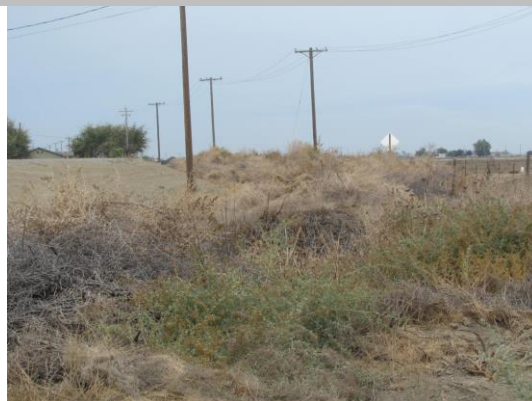
Photo 1 of 2 : FA_2016_RD2063_112_2_20161027_00093.jpg

Looking north at dense veg at landward toe and berm.

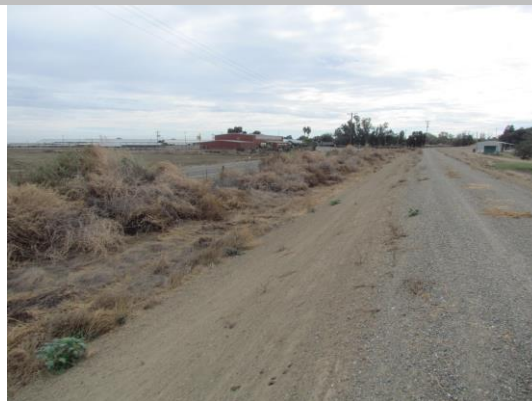
Photo 2 of 2 : FA_2016_RD2063_112_2_20161027_00092.jpg

Looking south at dense veg at landward toe and berm.

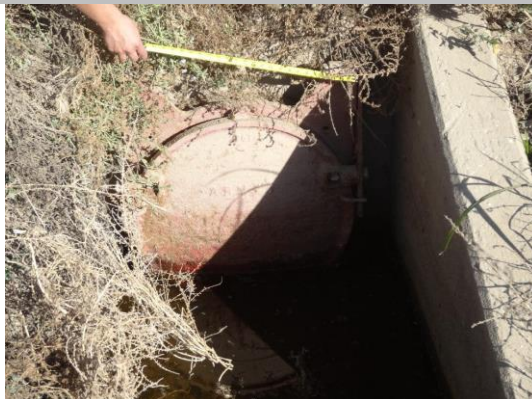
Photo 1 of 2 : UCIP_FA_2016_24583_43842.jpg

FS_ID:24583
DS_ID:22096
EP_NO: N/A
Repair Type: Non-Urgent
Crossing Status: Found
UCIP Comments: - new flap gate on waterside.- cleaning of outlet and inlet pipes required.
FIELD_STRUCT_DESC: 24-inch CM pipe through the levee 12.0 feet below the crown. Flap gate on the waterwad end. Concrete headwall on both ends. Installed by USCE 1961. O&M Manual SJR 006, Sept. 1961
FS Date: 11/5/2013

WS view: pipe, flap gate, and concrete headwall on drainage ditch.

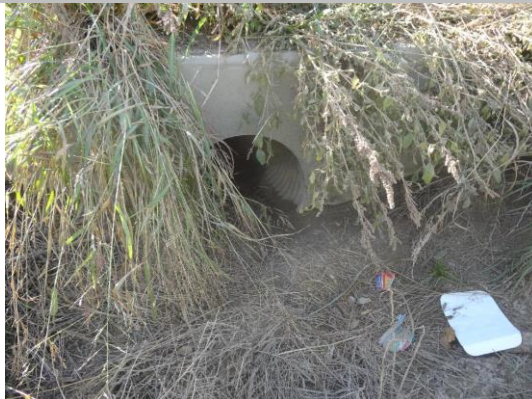
Photo 2 of 2 : UCIP_FA_2016_24583_43841.jpg

LS view: CM pipe and concrete headwall on levee toe.

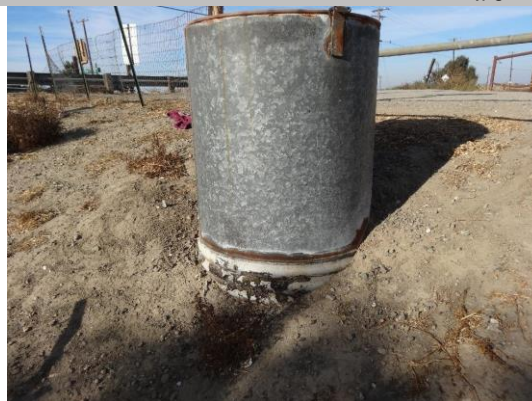
Photo 1 of 2 : UCIP_FA_2016_41746_43850.jpg

LM Start	4.10	Rating **	M	Issue No.	999
LM End	4.10	Issue Type +	En	Location *	LS
Category	Supplemental			GPS Latitude/Longitude	
				Start	End
Item	DWR UCIP Field Study			37.431846 °	37.431846 °
				-121.012716 °	-121.012716 °
DWR ID					
Comment Code					
Inspector Comment					
FS_ID:41746 DS_ID:22099 EP_NO: N/A Repair Type: Non-Urgent Crossing Status: Found UCIP Comments: Need to determine if annular space has been grouted or if repair/sleeving was done in accordance with a permit or Title 23. Slide gate not found in CM pipe riser on the waterward slope.Dense vegetation on waterside.Pipe only visible in CMP riser on waterside slope. FIELD_STRUCT_DESC: A smaller pipe sleeved into 24-inch CM pipe. 24-inch pipe through the levee 10.0 feet below the crown. Connects to concrete pipe irrigation system. Installed by USCE 1961. O&M Manual SJR 006, Sept. 1961. FS Date: 11/5/2013

WS view: CMP riser on levee slope. Steel riser on top of CMP.

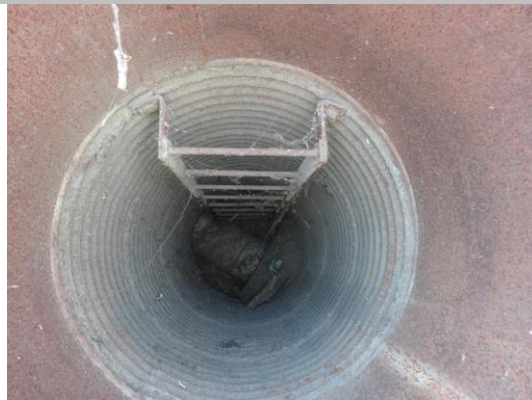
Photo 2 of 2 : UCIP_FA_2016_41746_43849.jpg

WS view: inside view of CMP riser on levee slope. Steel pipe and 24" CMP visible inside the riser.

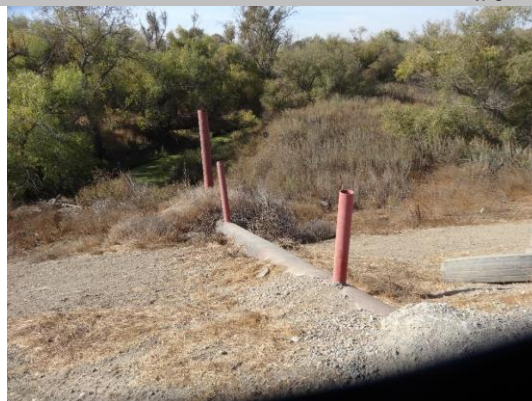
Photo 1 of 2 : UCIP_FA_2016_25025_45110.jpg

LM Start	4.17	Rating **	M	Issue No.	983
LM End	4.17	Issue Type +	En	Location *	LS
Category	Supplemental			GPS Latitude/Longitude	
				Start	End
Item	DWR UCIP Field Study			37.431029 °	37.431029 °
				-121.011865 °	-121.011865 °
DWR ID					
Comment Code					
Inspector Comment					
FS_ID:25025 DS_ID:24732 EP_NO: N/A Repair Type: Non-Urgent Crossing Status: Found UCIP Comments: - new pipe to pump.- overhead power line.- soil cover over the pipe seems not enough. FIELD_STRUCT_DESC: A 24-inch steel pipe through the levee at crown level. A thin layer of dirt acts as cover to the pipe. Pump house on steel structure in landside drainage ditch. Pump house and pipe on landside look new. Old wooden walkway to the pumphouse. Three new air vents on waterside pipe. Pipe opens on waterside. Exposed old pipe on waterside. FS Date: 11/6/2013

WS view: air vents (top- red) on exposed steel pipe.

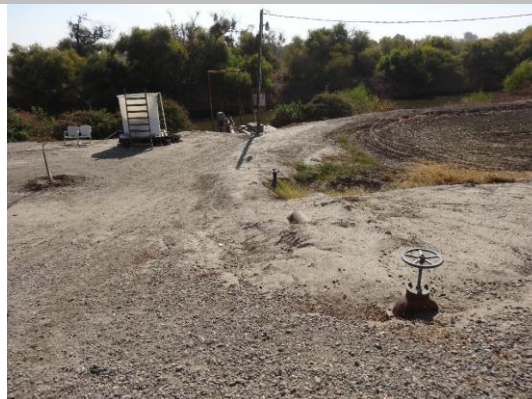
Photo 1 of 2 : UCIP_FA_2016_25028_45125.jpg

LM Start	4.58	Rating **	M	Issue No.	984
LM End	4.58	Issue Type +	En	Location *	LS
Category	Supplemental			GPS Latitude/Longitude	
				Start	End
Item	DWR UCIP Field Study			37.429501 °	37.429501 °
				-121.005667 °	-121.005667 °
DWR ID					
Comment Code					
Inspector Comment					
FS_ID:25028 DS_ID:22103 EP_NO: N/A Repair Type: Non-Urgent Crossing Status: Found UCIP Comments: Leaky pipe joint on landside where pipe daylights.Power pole on waterside. FIELD_STRUCT_DESC: 10-inch steel pipe through the levee 4.0 feet below the crown. Gate valve on waterside slope. Siphon breaker on landside slope. Pipe daylights halfway down landward slope and empties into a concrete standpipe at landward toe. Pump at top of the bank on waterside. Installed by USCE 1961. O&M Manual SJR 006, Sept. 1961. FS Date: 11/6/2013

WS view: overview of waterside- gate valve and power pole on levee slope.

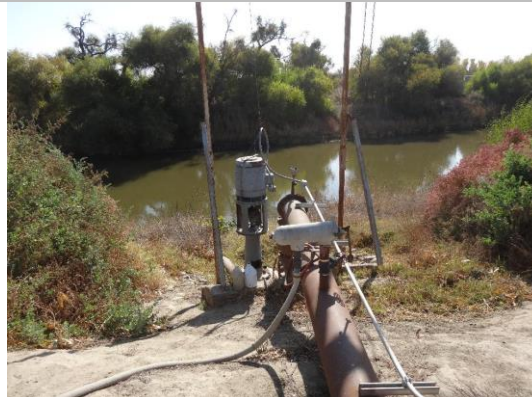
Photo 2 of 2 : UCIP_FA_2016_25028_45124.jpg

WS view: pump, pipe and other appurtenances on levee toe.

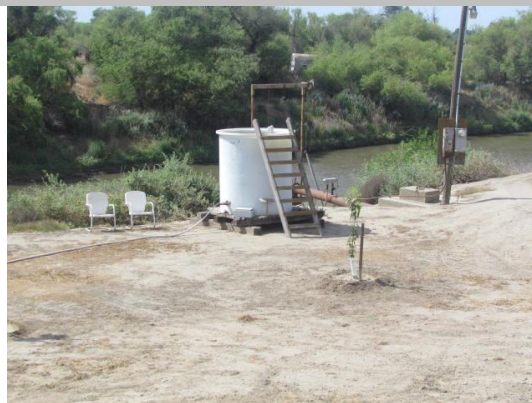
Photo 1 of 2 : FA_2016_RD2063_112_31_20161007_00009.jpg

Looking west at water tank on waterward berm.

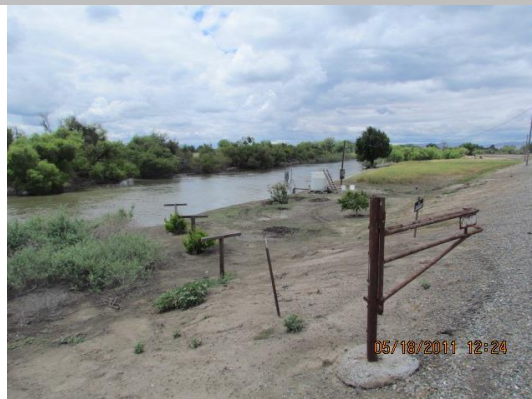
Photo 2 of 2 : FA_2016_RD2063_112_31_20161007_00010.jpg

Looking south at grapevines and fruit trees on waterside berm.

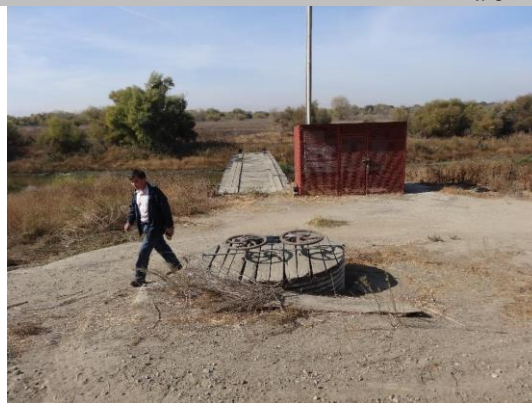
Photo 1 of 2 : UCIP_FA_2016_41669_45131.jpg

Comment Code					
Inspector Comment					
FS_ID:41669					
DS_ID:22105					
EP_NO: N/A					
Repair Type: Non-Urgent					
Crossing Status: Found					
UCIP Comments: Abandoned pipe should be done so properly.- rubber pipe attached to steel pipe on waterside.- a concrete standpipe on landside too.- overhead power line.- abandoned pipe and pile structure. Abandoned timber walkway on waterside.					
FIELD_STRUCT_DESC: 1 of 2: Two 12-inch steel pipes encased in reinforced concrete through levee 9.0 feet below crown. Two slide gates in 72-inch CM pipe riser on waterward slope. Two pumps on floating structure in river. Concrete distribution box on landward toe of the levee. Installed by USCE 1961. O&M Manual SJR 006, Sept. 1961.					
FS Date: 11/6/2013

WS view: CMP riser, abandoned walkway, power pole on levee slope.

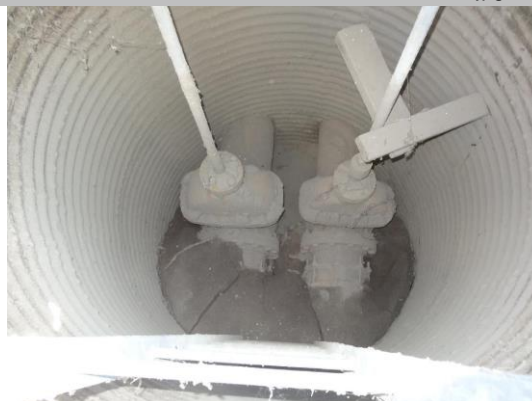
Photo 2 of 2 : UCIP_FA_2016_41669_45130.jpg

WS view: two gate valves inside CMP riser on levee slope.

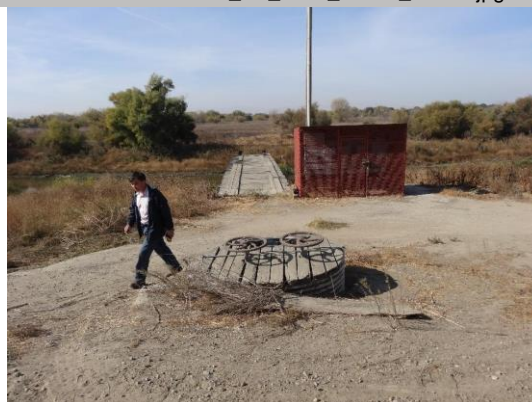
Photo 1 of 2 : UCIP_FA_2016_41670_43905.jpg

WS view: CMP riser, abandoned walkway, power pole on levee slope.

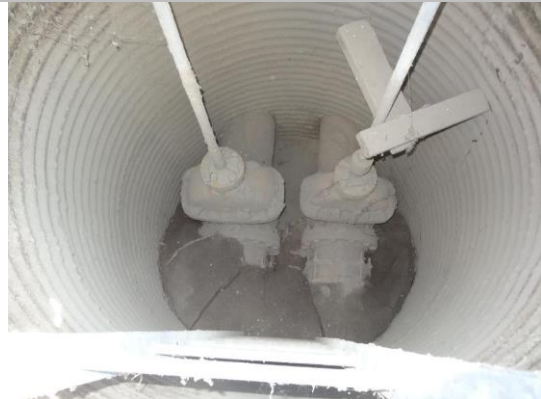
Photo 2 of 2 : UCIP_FA_2016_41670_43904.jpg

WS view: two gate valves inside CMP riser on levee slope.

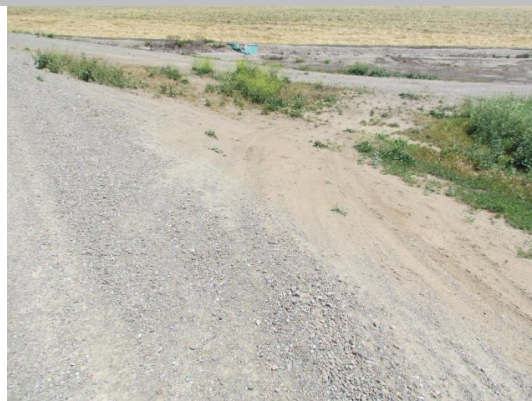
Photo 1 of 2 : FA_2016_RD2063_112_50_20161007_00013.jpg

Looking southeast at slope damage on landward slope.

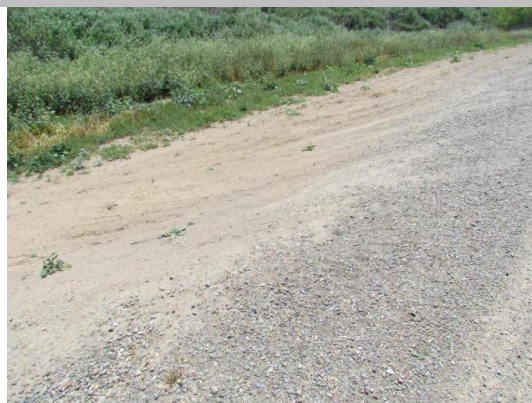
Photo 2 of 2 : FA_2016_RD2063_112_50_20161007_00014.jpg

Looking northeast at slope damage on landward slope.

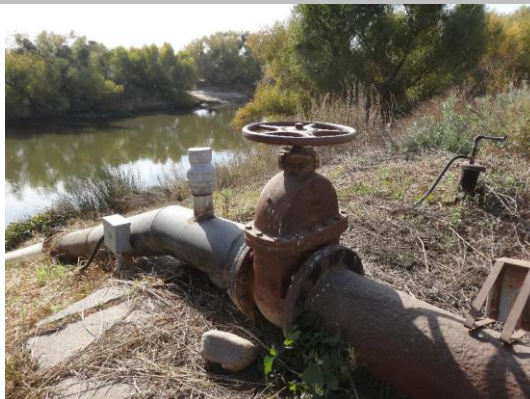
Photo 1 of 2 : UCIP_FA_2016_24628_43938.jpg

WS view: steel pipe, gate valve, air vent on levee berm.

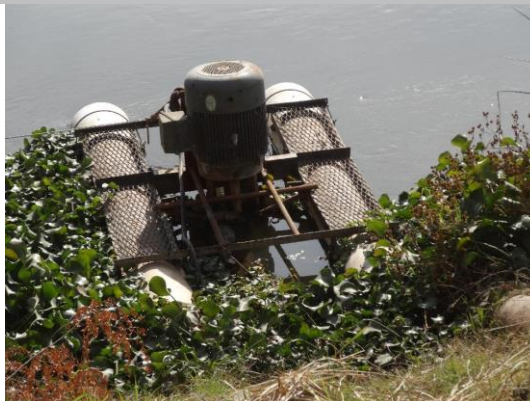
Photo 2 of 2 : UCIP_FA_2016_24628_43937.jpg

WS view: pump on floating structure in the stream.

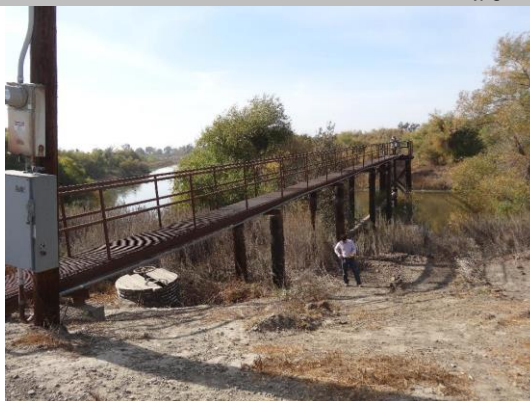
Photo 1 of 2 : UCIP_FA_2016_24629_43943.jpg

WS view: power pole, walkway to pump, CMP riser, and pipe on waterside slope.

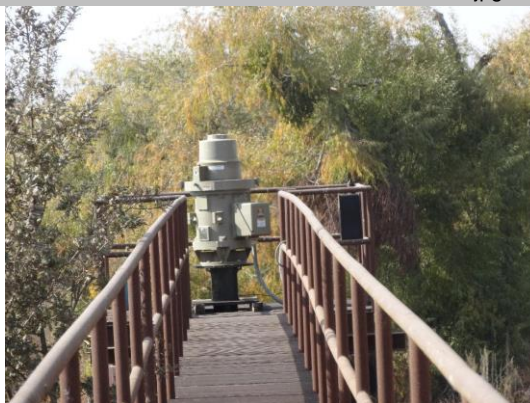
Photo 2 of 2 : UCIP_FA_2016_24629_43942.jpg

WS view: walkway to pump and pump on pile structure in the stream.

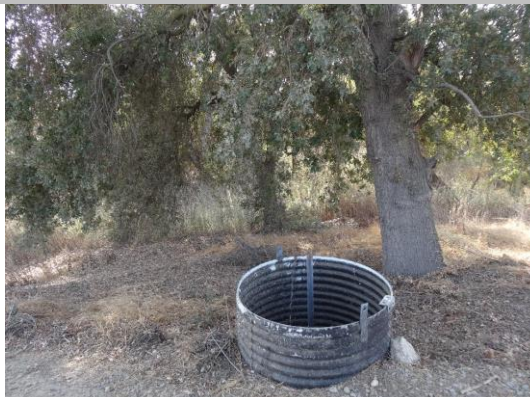
Photo 1 of 2 : UCIP_FA_2016_25031_45141.jpg

WS view: CMP riser with slide gate. Missing slide gate handwheel.

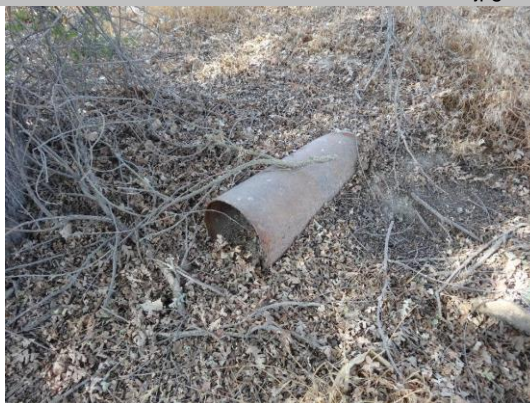
Photo 2 of 2 : UCIP_FA_2016_25031_45140.jpg

WS view: steel pipe with open-end on waterside slope.

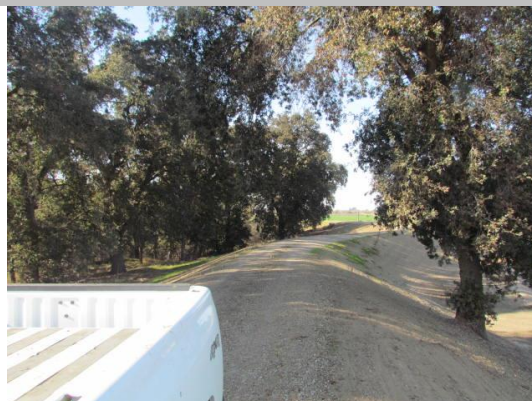
Photo 1 of 1 : FA_2016_RD2063_112_7_20161007_00003.jpg

Looking north at overhanging tree on landward slope.

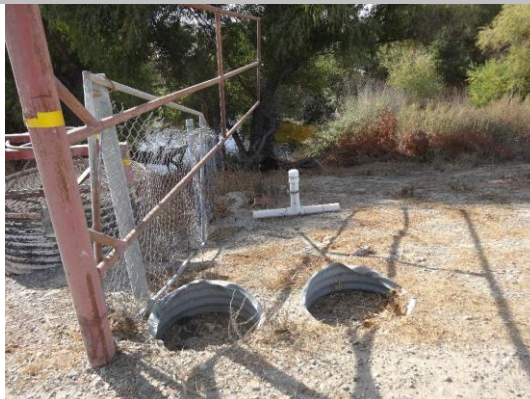
Photo 1 of 2 : UCIP_FA_2016_24651_44005.jpg

WS view: two siphon breakers in CMP risers on levee slope.

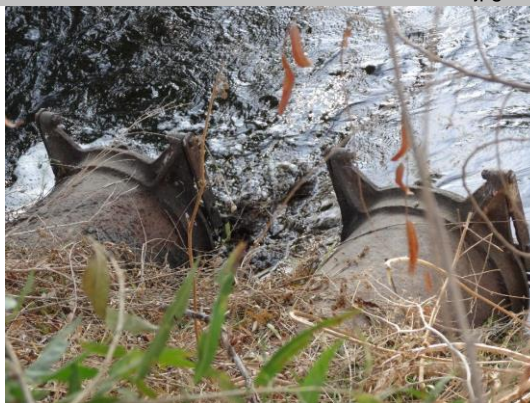
Photo 2 of 2 : UCIP_FA_2016_24651_44004.jpg

WS view: two flap gates on outfall pipe ends.

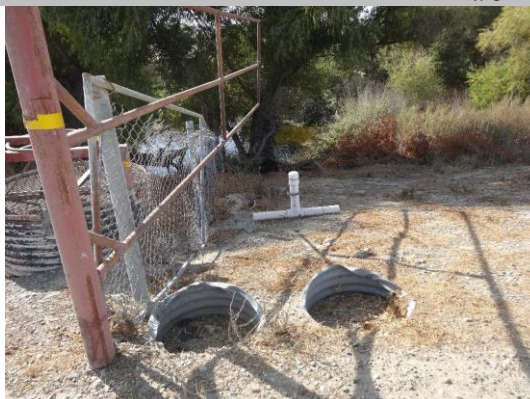
Photo 1 of 2 : UCIP_FA_2016_24652_44008.jpg

WS view: two siphon breakers in CMP risers on levee slope.

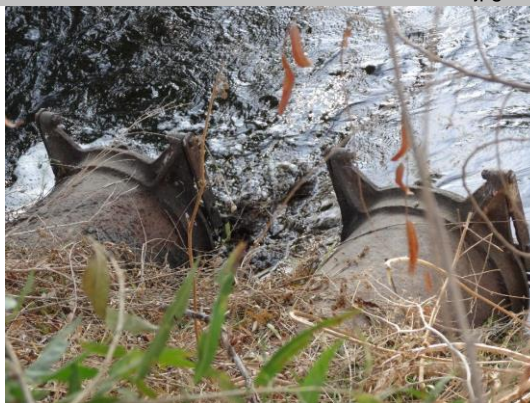
Photo 2 of 2 : UCIP_FA_2016_24652_44007.jpg

WS view: two flap gates on outfall pipe ends.

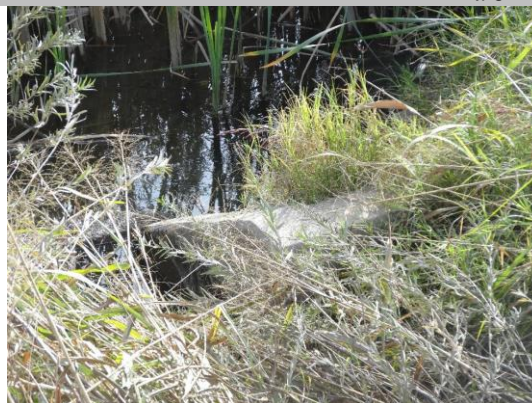
Photo 1 of 2 : UCIP_FA_2016_24645_43988.jpg

WS view: concrete U type headwall on channel bank. Not accessible.

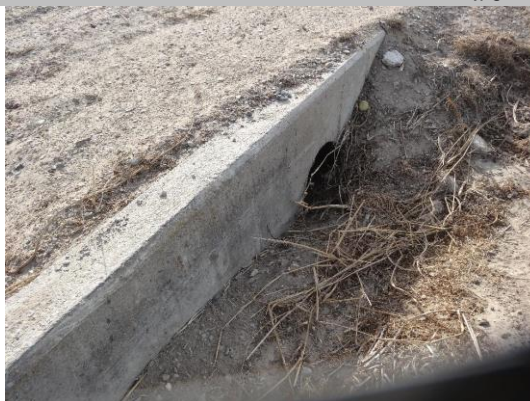
Photo 2 of 2 : UCIP_FA_2016_24645_43987.jpg

LS view: concrete headwall and partially blocked inlet opening.

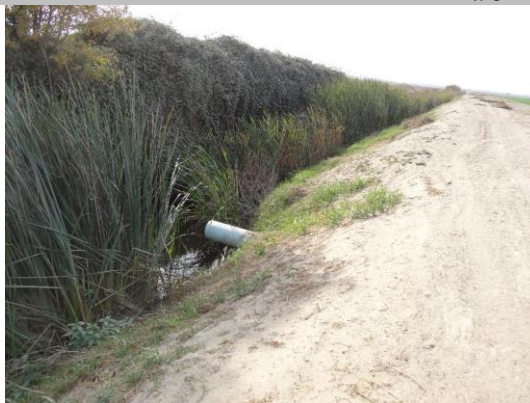
Photo 1 of 2 : UCIP_FA_2016_50221_43990.jpg

WS view: PVC pipe with open end on levee slope.

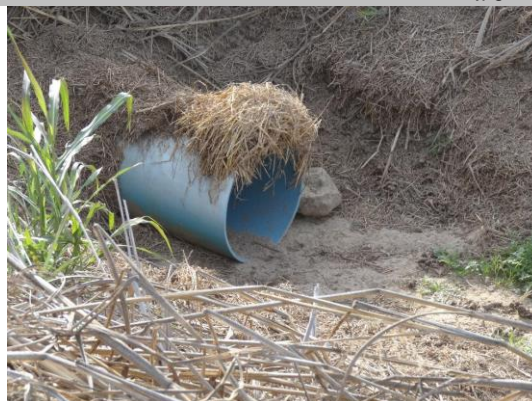
Photo 2 of 2 : UCIP_FA_2016_50221_43989.jpg

LS view: PVC pipe with open end on levee toe.

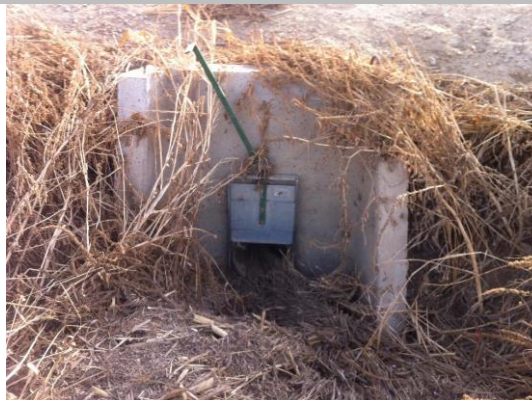
Photo 1 of 2 : UCIP_FA_2016_50222_43993.jpg

LS view: U type concrete headwall, slide gate, and pipe on levee toe.

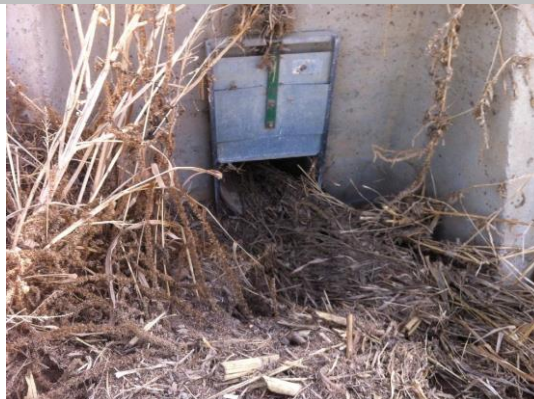
Photo 2 of 2 : UCIP_FA_2016_50222_43992.jpg

LS view: closer view of U type concrete headwall, slide gate, and pipe on levee toe.
